Memorandum

Project: 151755 – Facade Inspection, The Carillon, 185 Massachusetts Avenue, Boston, MA

Subject: GFRC Coatings, Repair Options

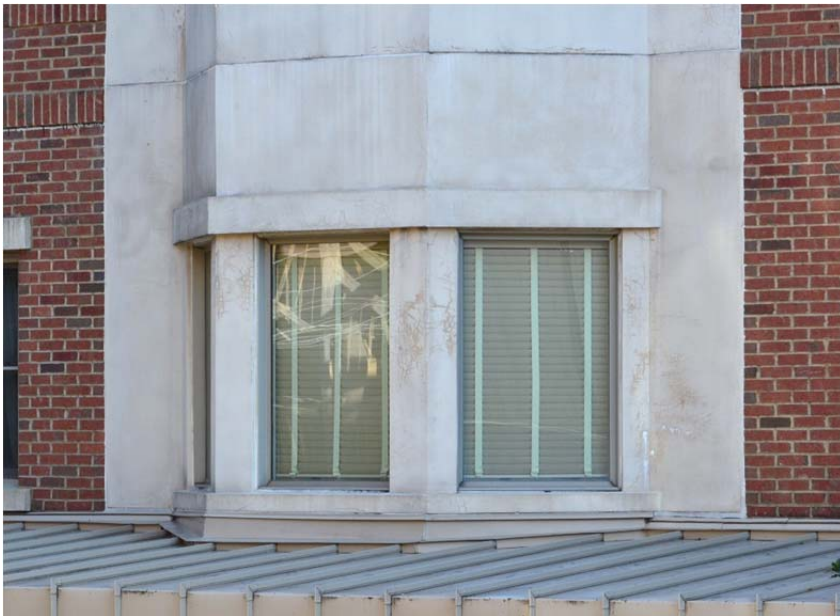
Phoenix Bay State Construction Co., Inc. (Phoenix), with Simpson Gumpertz & Heger Inc. (SGH) guidance, has completed installation of the KEIM coating products on the west face of the building. Photo 1 shows the state of the mockup area prior to cleaning of the GFRC panels and installation of the KEIM products. Photos 2 through 4 show the mockup area after completion of the coating installation and replacement of the sealant joints. Photos 3 and 4 show existing conditions on the level above the mockup area that are similar to the condition of the mockup area prior to our work.

Mockup area prior to cleaning and coating installation (5 November 2016).

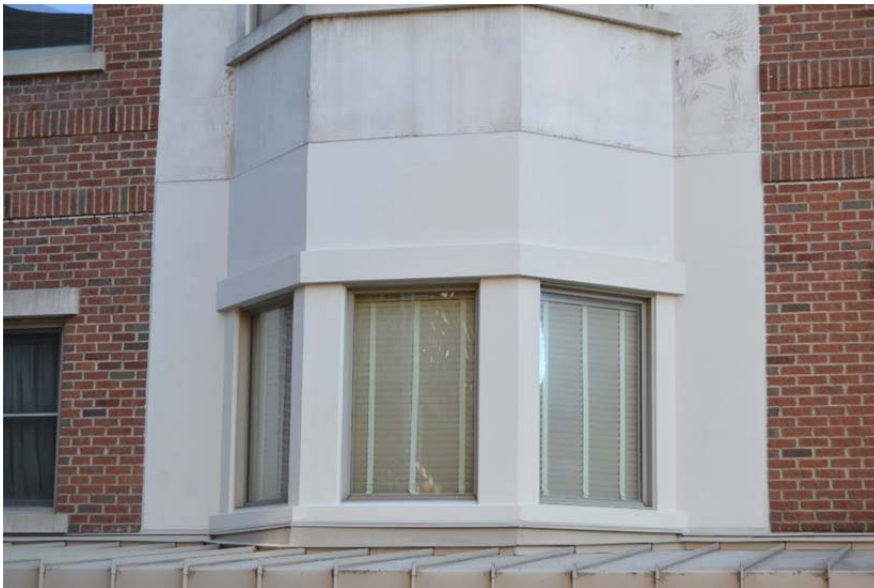
Photo 2

Mockup area, coating installation complete (18 February 2016).

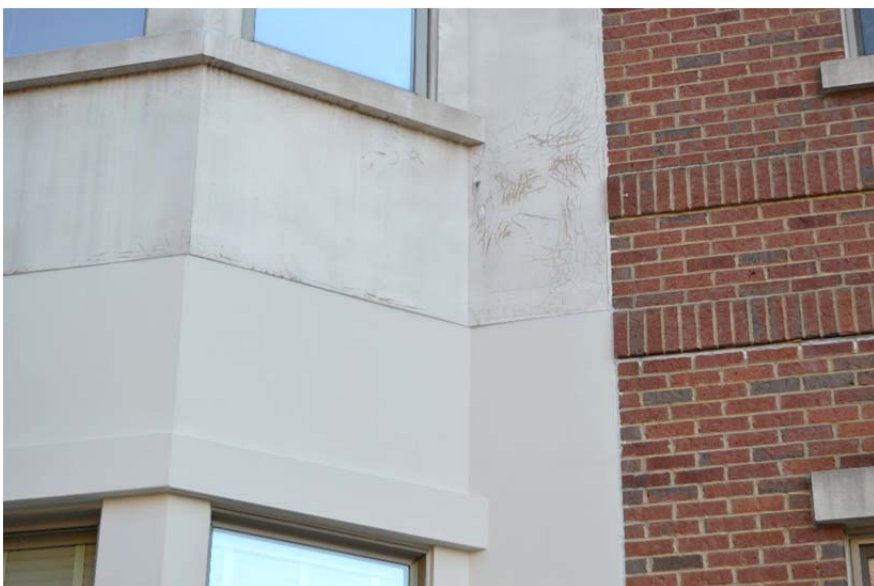
Photo 3

Mockup area and deterioration of level above.

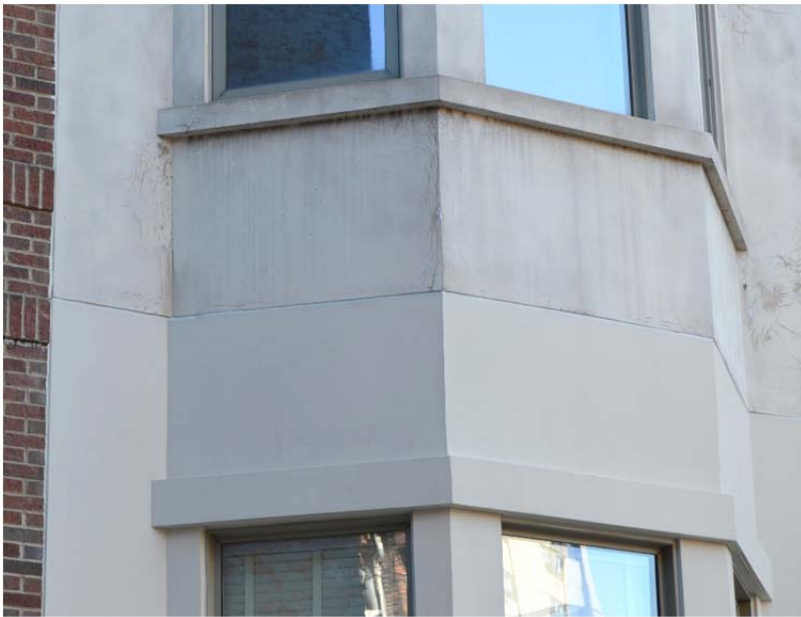
Photo 4

Mockup area and deterioration of level above.

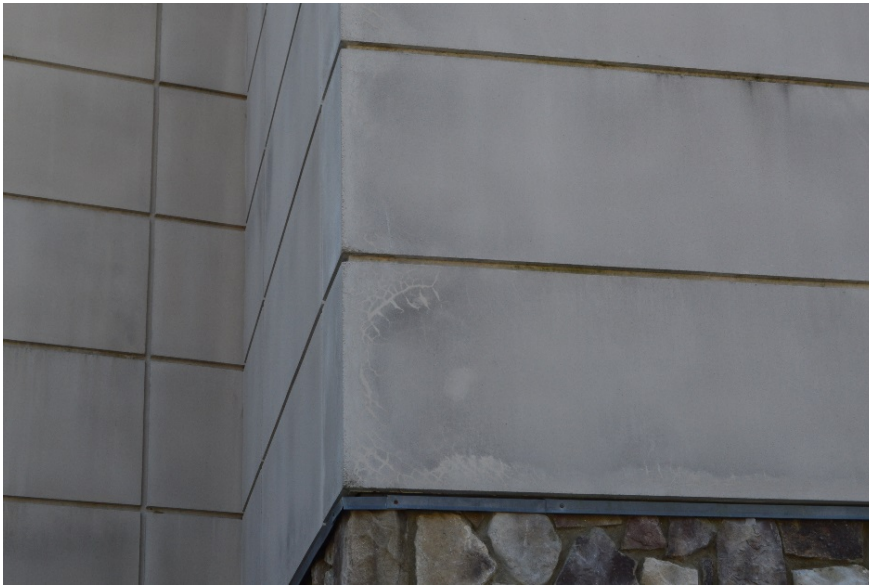
Photo 7

The Center of the Arts building at Endicott College has similar cracking (Photo 7) and a small amount of efflorescence staining (Photo 8) similar to The Carillon. It appears the GFRC panels have been cleaned in some areas of the building. However, where the panels have not been cleaned, cracks, stains, and environmental buildup are clearly visible (Photo 9).

GFRC cracks, Endicott College.

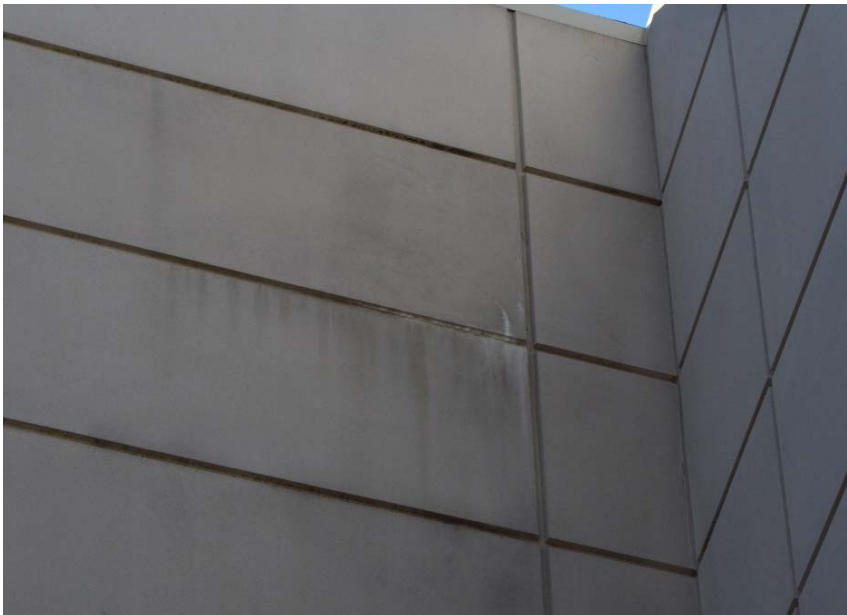
Photo 8

Efflorescence staining, Endicott College.

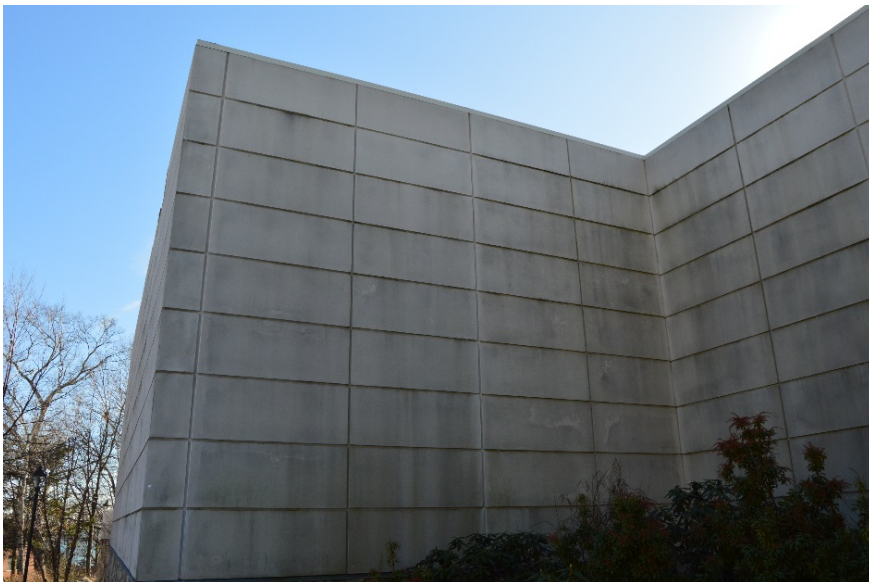
Photo 9

Uncleaned portion the GFRC panels, Endicott College.

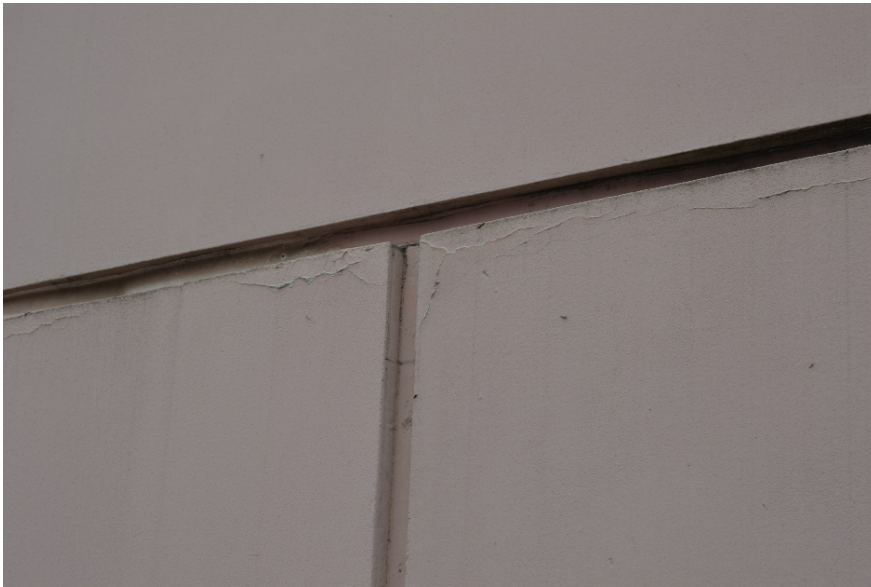
Photo 10

The St. George condominiums also have GFRC panel cracking (Photo 10) similar to The Carillon and some staining below windows and other areas with water runoff (Photo 11). The panels at St. George condominiums are coated with what appears to be an acrylic coating. The coating is blistering and peeling in a number of locations (Photos 12 and 13).

GFRC panels cracks,
St. George condominiums.

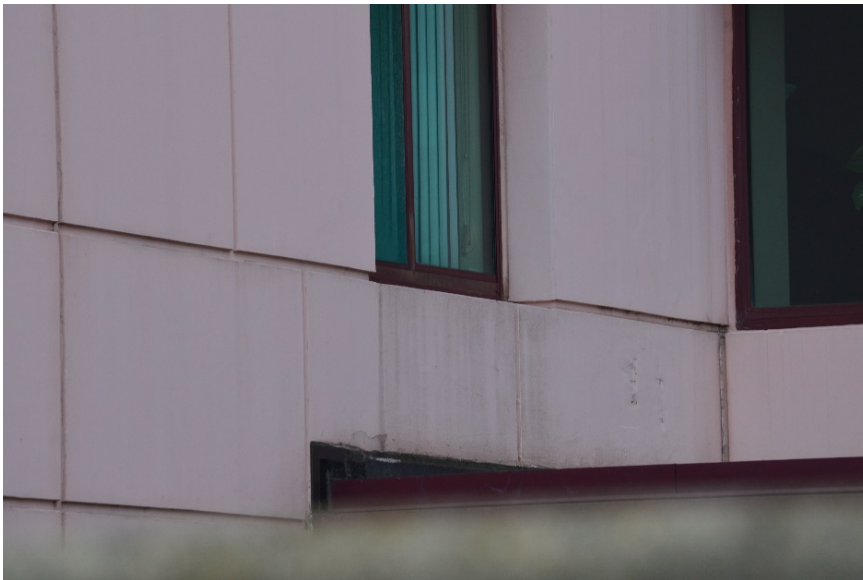
Photo 11

Staining on GFRC panels,
St. George condominiums.

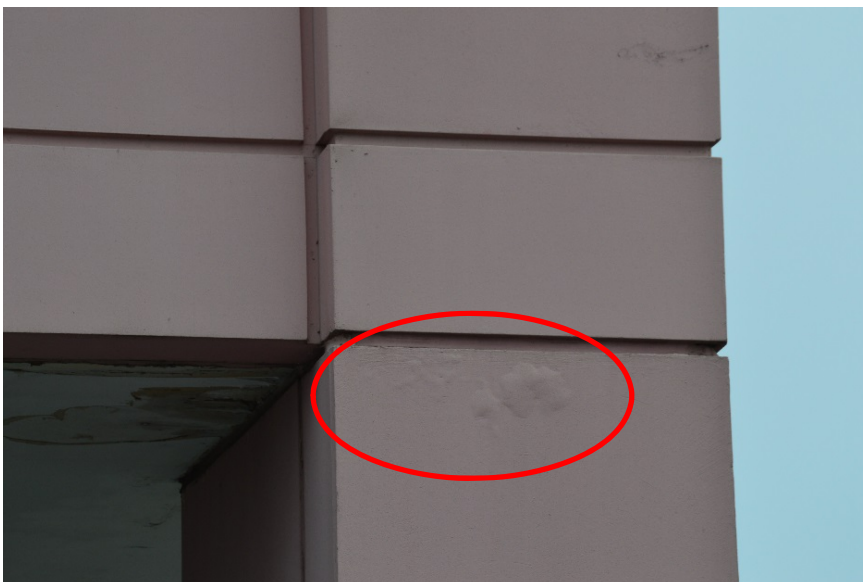
Photo 12

Blistered GFRC coating,
St. George condominiums.

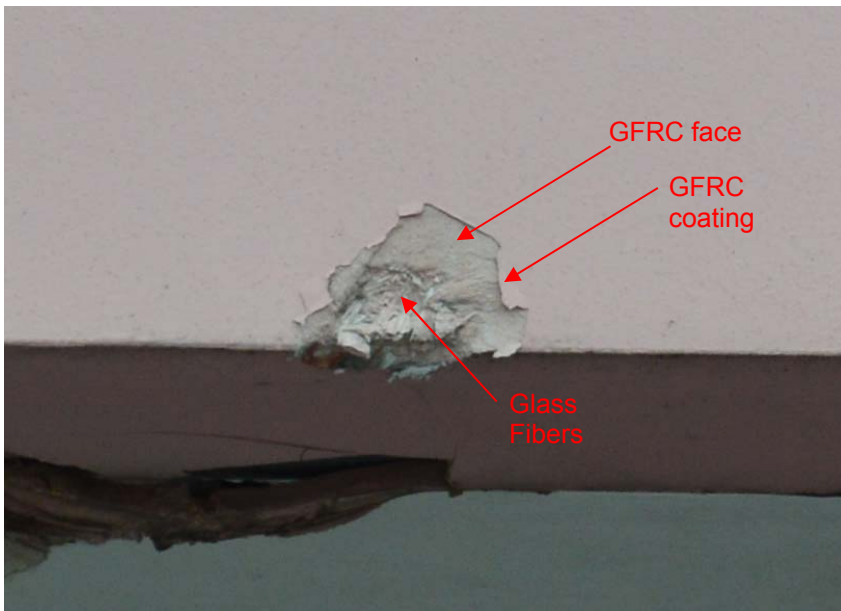
Photo 13

Peeled GFRC coating,
St. George condominiums
