# Memorandum

Facade Inspection, The Carillon, 185 Massachusetts Avenue,

GFRC Coatings, Repair Options

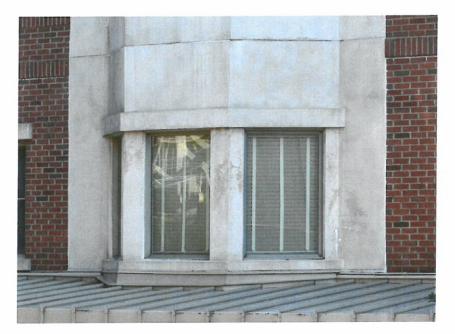
#### Photo 1

Phoenix Bay State Construction Co., Inc. (Phoenix), with Simpson Gumpertz & Heger Inc. (SGH) guidance, has completed installation of the KEIM coating products on the west face of the building. Photo 1 shows the state of the mockup area prior to cleaning of the GFRC panels and installation of the KEIM products. Photos 2 through 4 show the mockup area after completion of the coating installation and replacement of the sealant joints. Photos 3 and 4 show existing conditions on the level above the mockup area that are similar to the condition of the mockup area prior to our work.

Mockup area prior to cleaning and coating installation (5 November 2016).

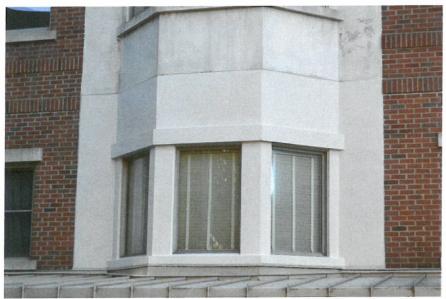
### Photo 2

Mockup area, coating installation complete (18 February 2016).

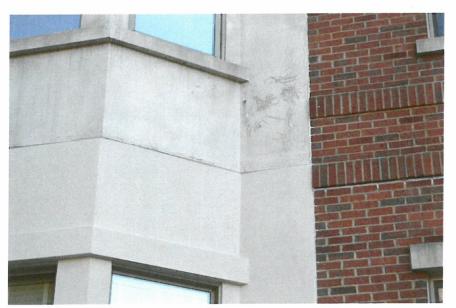
Photo 3

Mockup area and deterioration of level above.

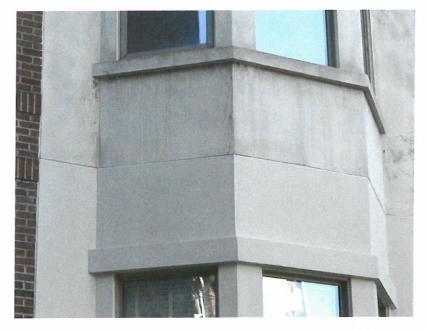
#### Photo 4

Mockup area and deterioration of level above.

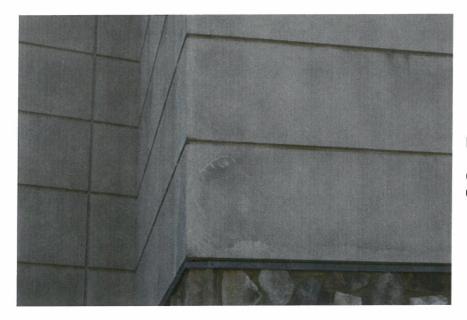
Photo 7

The Center of the Arts building at Endicott College has similar cracking (Photo 7) and a small amount of efflorescence staining (Photo 8) similar to The Carillon. It appears the GFRC panels have been cleaned in some areas of the building. However, where the panels have not been cleaned, cracks, stains, and environmental buildup are clearly visible (Photo 9).

GFRC cracks, Endicott College.

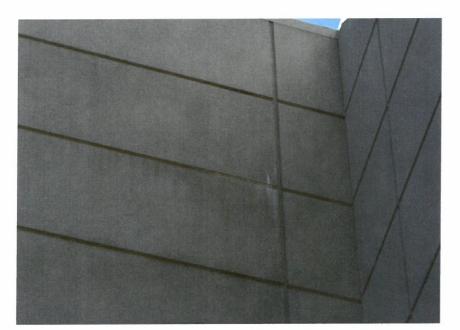
Photo 8

Efflorescence staining, Endicott College.

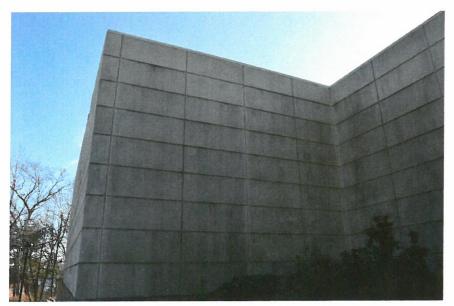
Photo 9

Uncleaned portion the GFRC panels, Endicott College.

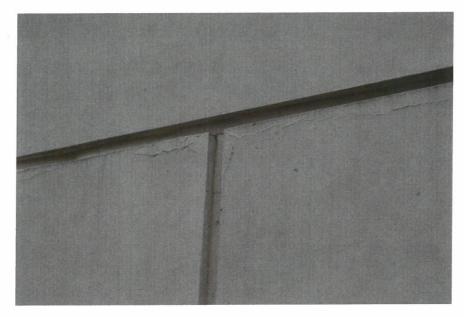
Photo 10

The St. George condominiums also have GFRC panel cracking (Photo 10) similar to The Carillon and some staining below windows and other areas with water runoff (Photo 11). The panels at St. George condominiums are coated with what appears to be an acrylic coating. The coating is blistering and peeling in a number of locations (Photos 12 and 13).

GFRC panels cracks,
St. George condominiums.

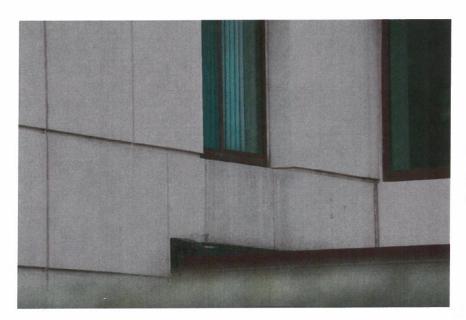
Photo 11
Staining on GFRC panels, St. George condominiums.

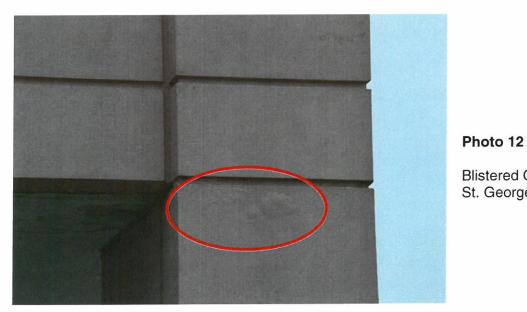
Blistered GFRC coating, St. George condominiums.

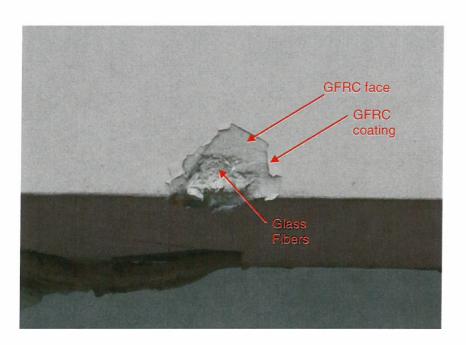
Photo 13

Peeled GFRC coating,
St. George condominiums
