Condominium Capital Needs Assessment and Replacement Reserve Analysis

Prepared for:

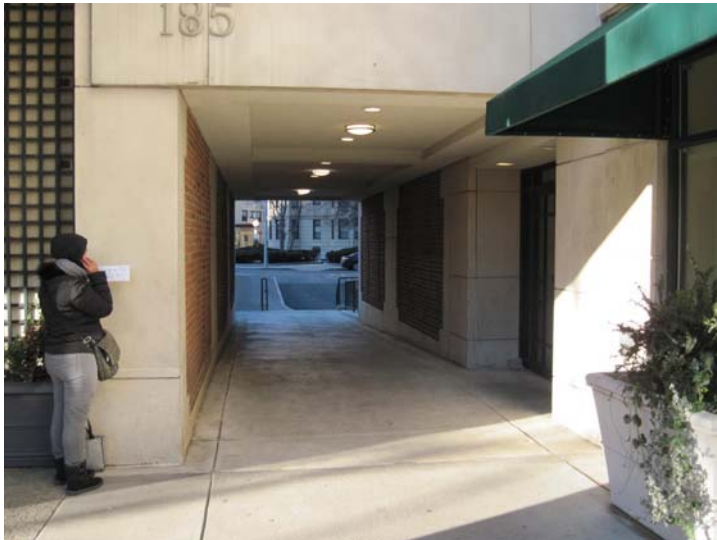
Limited site elements include this concrete walkway leading from the front Massachusetts Ave elevation to the rear elevation and public alley.

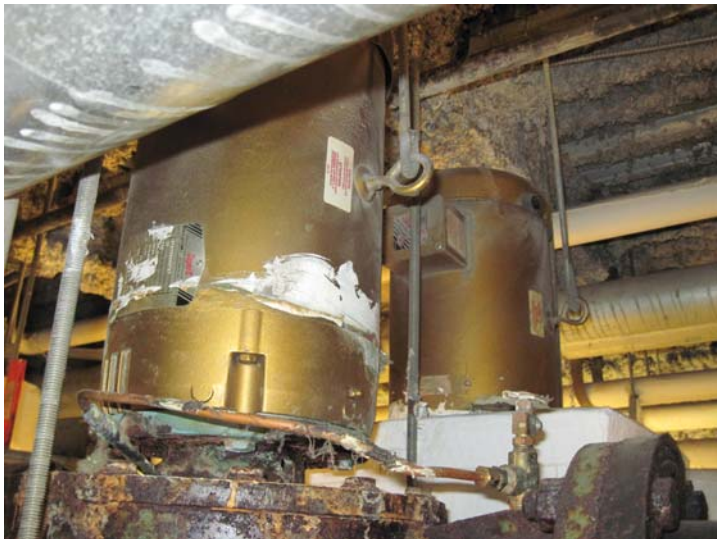
The main loop water is circulated by these Baldor 10-horsepower pumps. The primary pump runs continuously, and the backup pump is used only in the event that the primary pump fails.

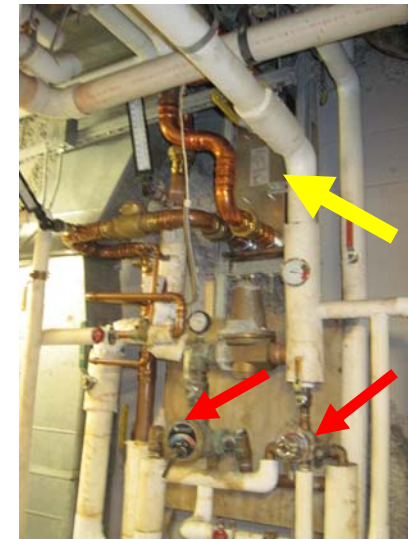
Building domestic hot water is produced by passing the boiler water through this Alfa Laval brazed plate heat exchanger (yellow). The two thermostatic mixing valves (red) temper the DHW to a safe-use temperature.

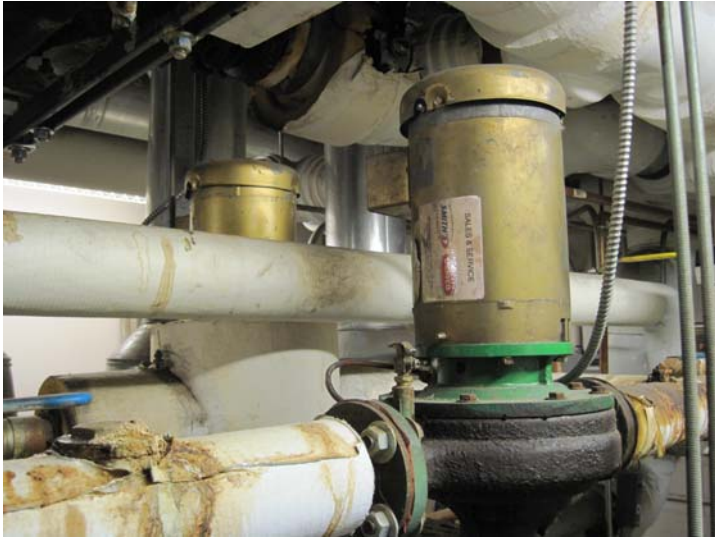
The domestic hot water is circulated by these Baldor 1.5-horsepower pumps. The primary pump runs continuously, and the backup pump is used only in the event that the primary pump fails.

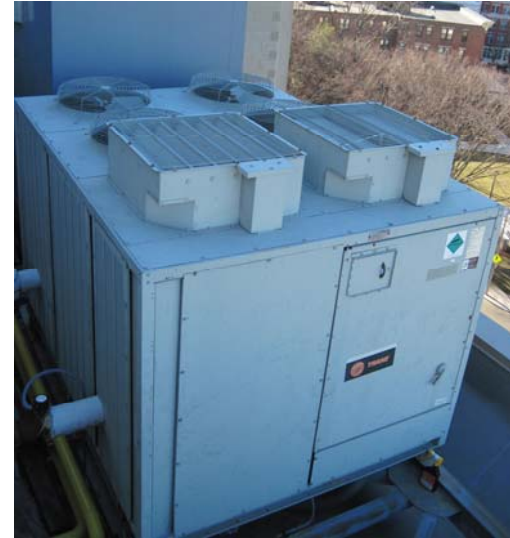
During the cooling months, the Trane 60-ton air-cooled liquid chiller removes heat extracted from the residences into the building loop via the fan coil units. The cooled building loop then cycles back through the fan coil units to extract more heat.

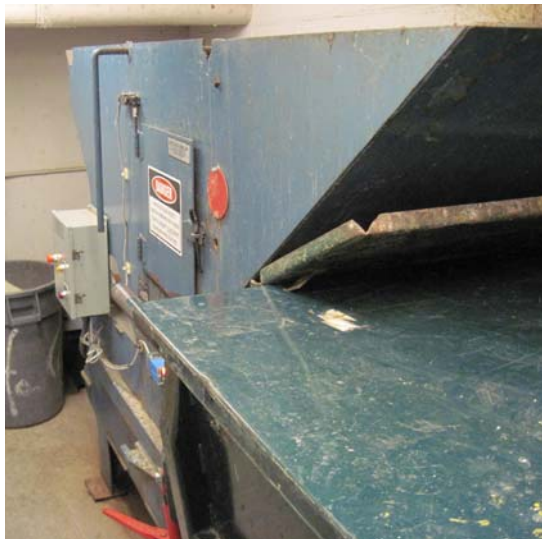
View of the original International Dynetics 5-hp shoot-fed horizontal hydraulic trash compactor with two cubic yard container (replaced 2010).

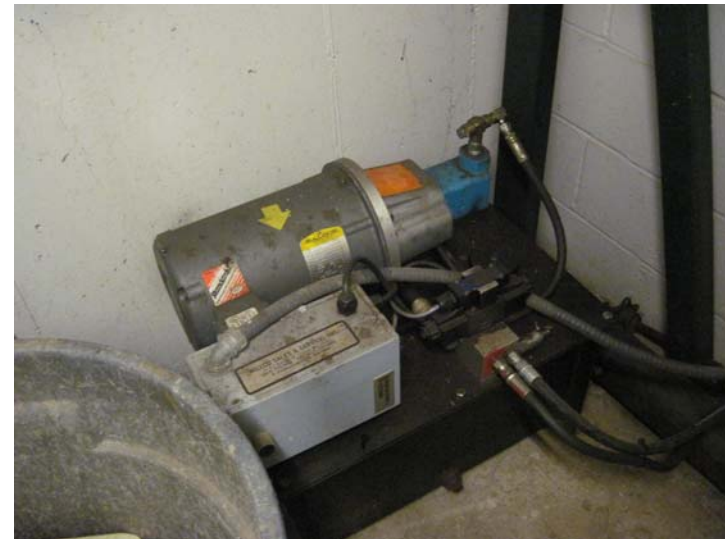
The compactor is operated by this Baldor 5-horsepower hydraulic pump.

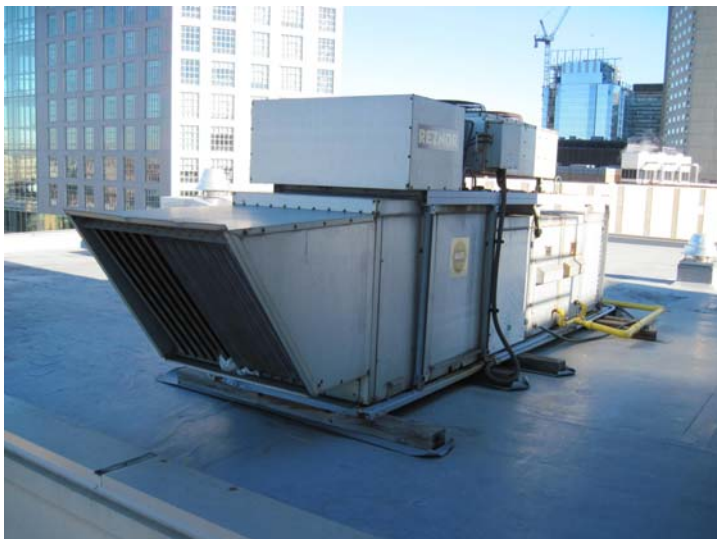
A Reznor makeup air unit (MAU) with 300-MBH gas heating unit and 22.5-ton electric packaged DX cooling unit provides fresh heated and conditioned air to the hallways and lobby.

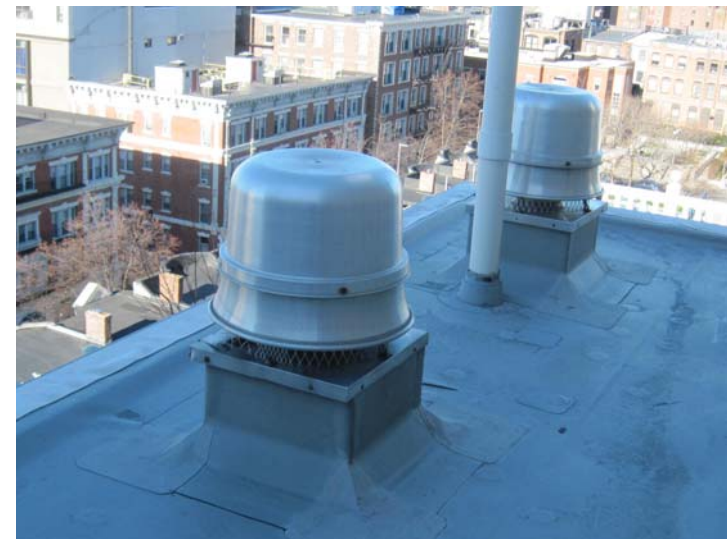
Several mushroom type rooftop powered fans serve the exhaust needs of the entry vestibule, trash room, and residence bathrooms, kitchens, and dryers.

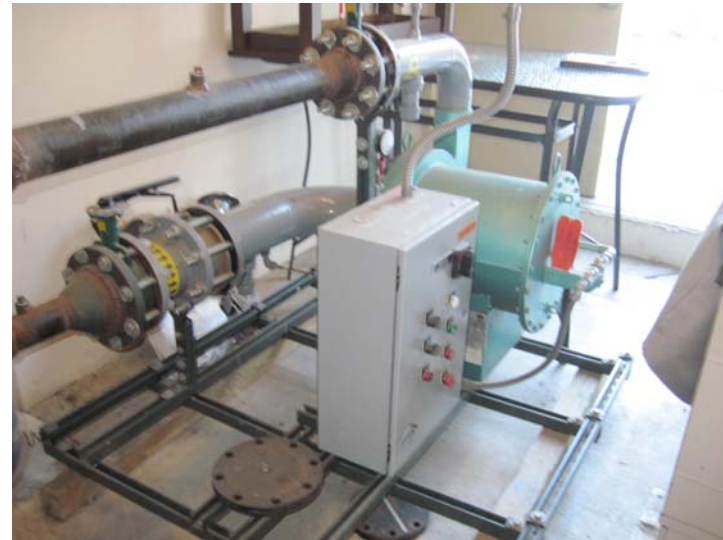
The building features an Eclipse centrifugal hermetic natural gas pressure booster system located at the 9th floor common terrace storage room.

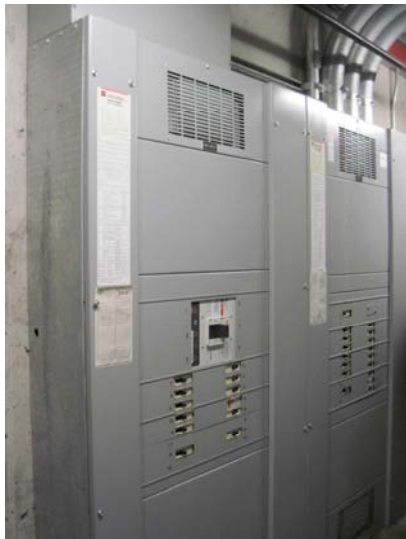
View of the Cutler Hammer building main disconnect panel

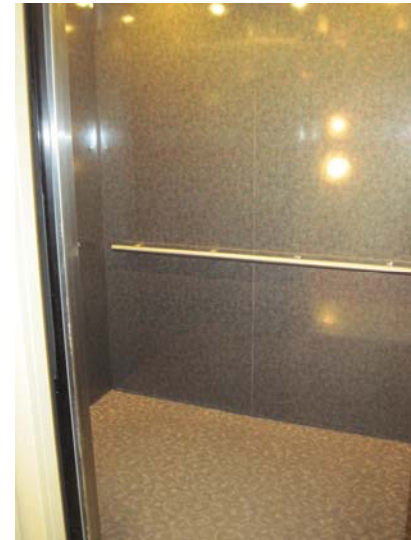
View of the elevator finishes.
High-gloss laminated particleboard panels with stainless steel trim and carpeted floors.

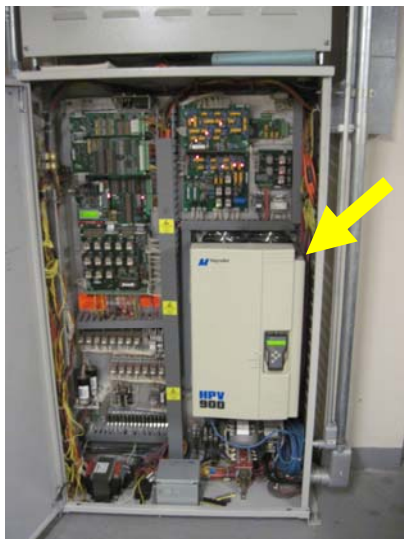
Both elevators feature solid state controls with Magnetek HPV-900 AC drives (arrow).

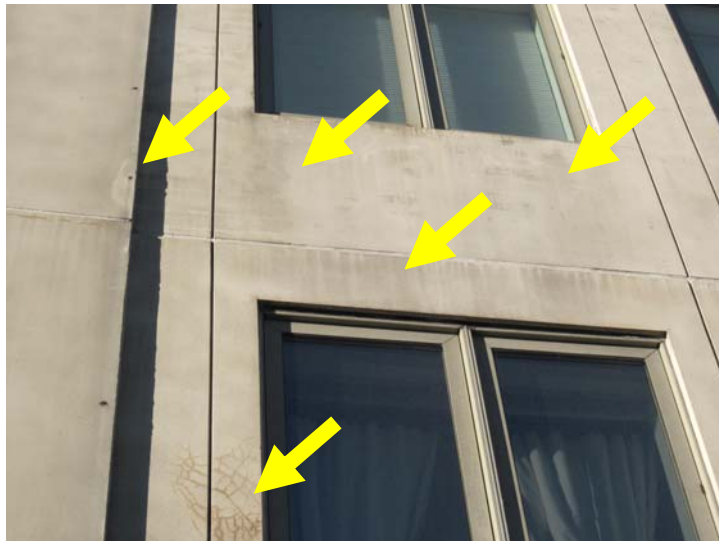
Close-up of localized spider-webbing and general overall surface deterioration of the GFRG cladding. (Viewed from front Mass Ave sidewalk looking at lower left corner of front building elevation)

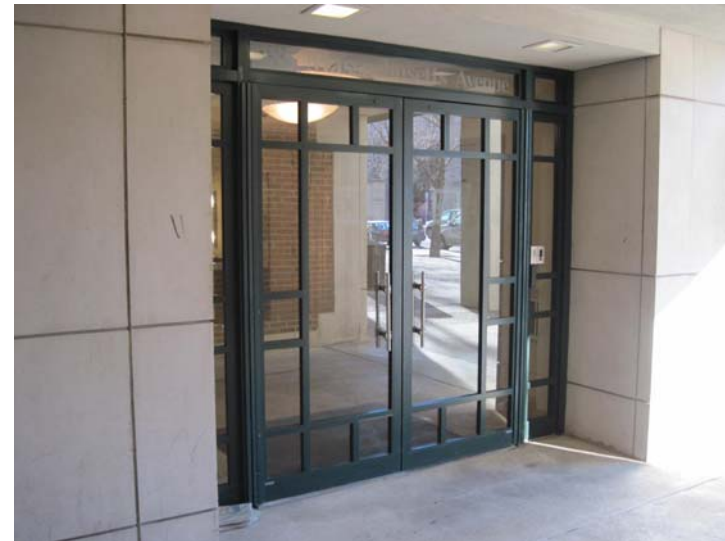
The main building entrance is located in the side-elevation breezeway and features a Craftsman style double-leaf set of aluminum-framed glass panel doors.

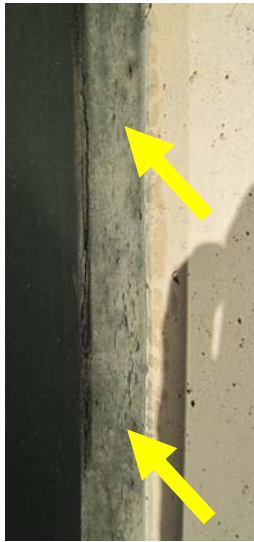
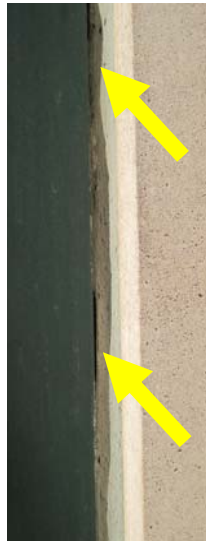
The aging window, door, GFRc panel, and control joint caulk is showing signs of splintering and cohesion failure; in need of replacement. (Two views of front elevation ground floor commercial unit window frame caulk)

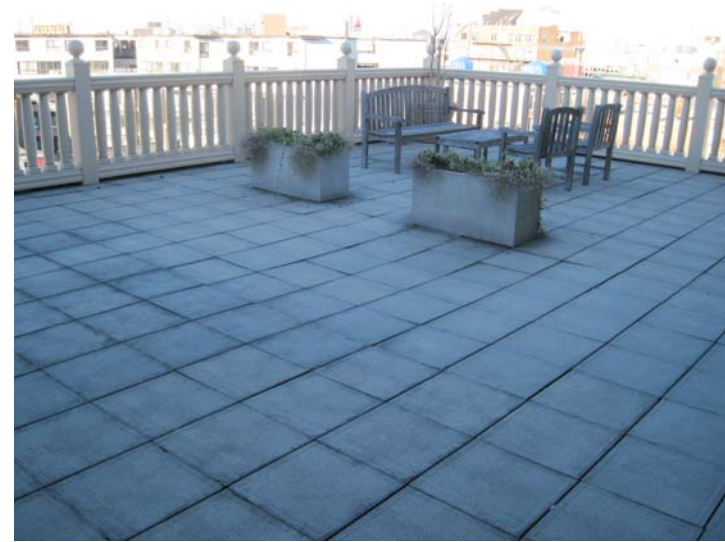
View of the 9th Floor rooftop common-use terrace with pre-cast concrete tile decking.

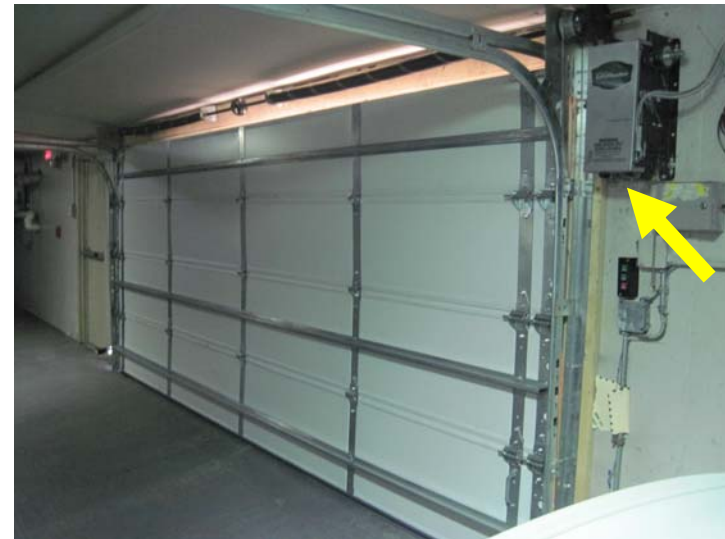
View of the newly replaced parking garage overhead door with wall-mounted LiftMaster power door opener (arrow).

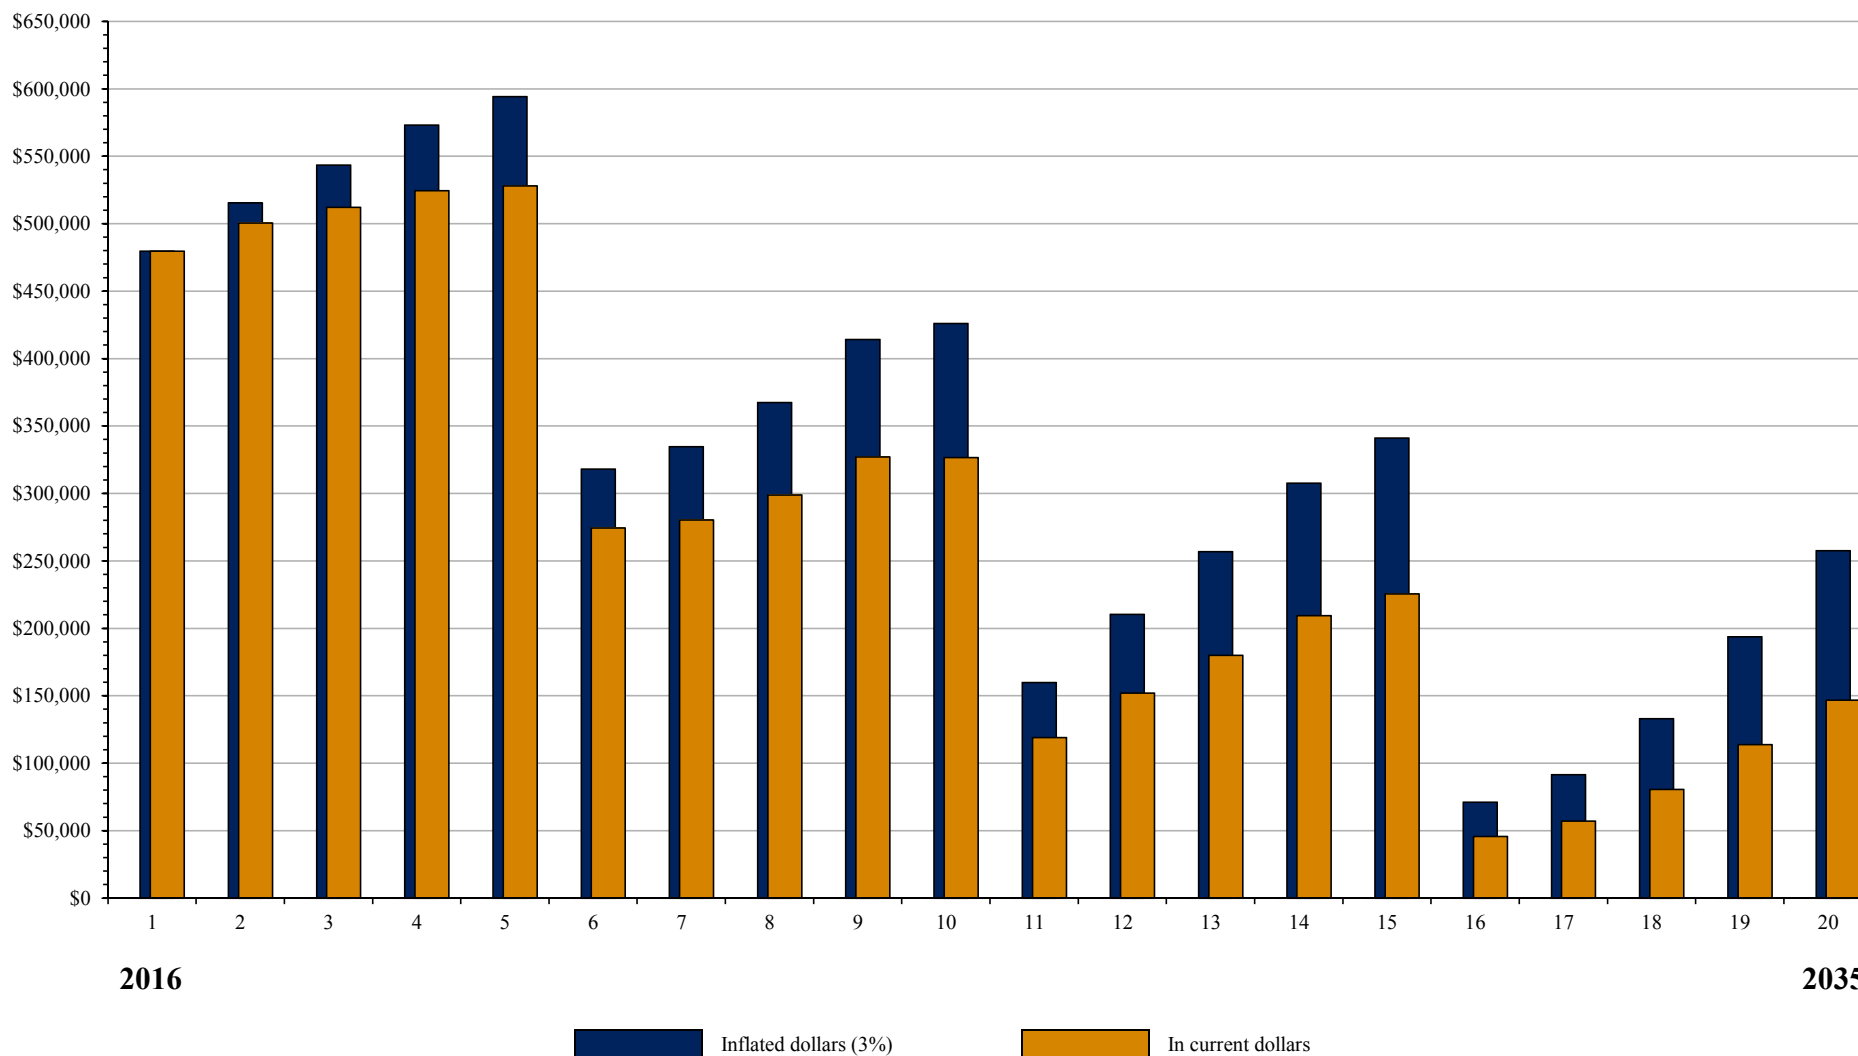
Reported Reserve Balance as of 01/14/2016 : **\$160,200**
Estimated Reserve Balance as of 01/01/2016 : **\$160,200**
Current annual contributions to reserves : **\$22,783**
