Memorandum

Project: 151755 – Facade Inspection, The Carillon, 185 Massachusetts Avenue, Boston, MA

Subject: GFRC Coatings, Repair Options

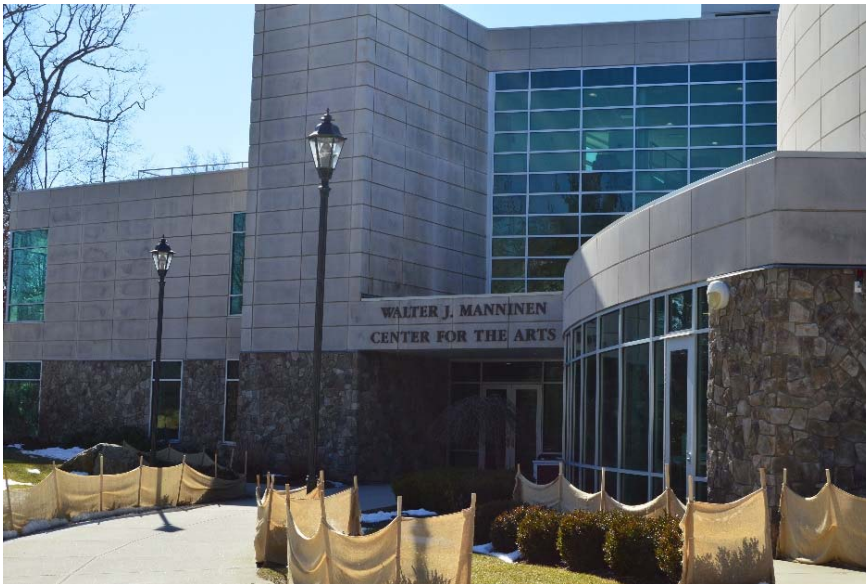
Photo 5

As part of our research on GFRC panels and their performance in the New England environment, we reviewed two similar projects: The Center of the Arts building at Endicott College (Photo 5) and The St. George condominiums in Revere, Massachusetts (Photo 6).

The Center of the Arts building, Endicott College, Beverly, MA.

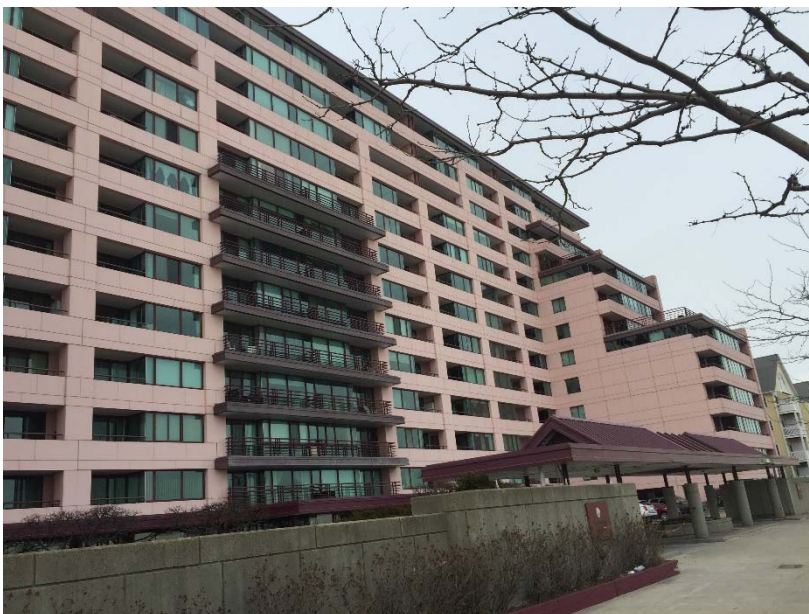
Photo 6

St. George condominiums, Revere, MA.
