# Memorandum

Facade Inspection, The Carillon, 185 Massachusetts Avenue,

GFRC Coatings, Repair Options

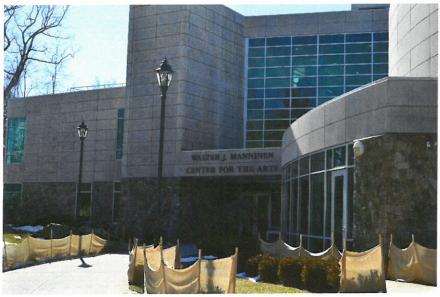
# Photo 5

As part of our research on GFRC panels and their performance in the New England environment, we reviewed two similar projects: The Center of the Arts building at Endicott College (Photo 5) and The St. George condominiums in Revere, Massachusetts.

The Center of the Arts building, Endicott College, Beverly, MA.

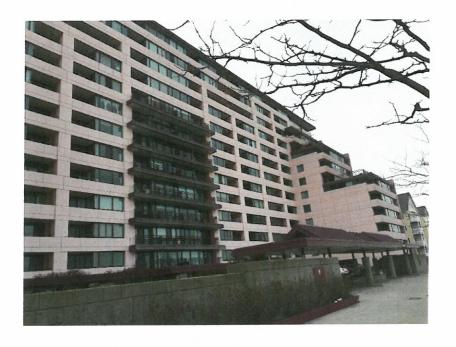
### Photo 6

St. George condominiums, Revere, MA.
